**California MLPA Master Plan Science Advisory Team**  
**Draft Recommendations for Evaluating Water and Sediment Quality Along**  
**the Palos Verdes Shelf – Supplemental Guidance to the Draft**  
**Recommendations for Considering Water Quality and Marine Protected**  
**Areas in the MLPA South Coast Study Region**  
*Draft revised August 31, 2009*

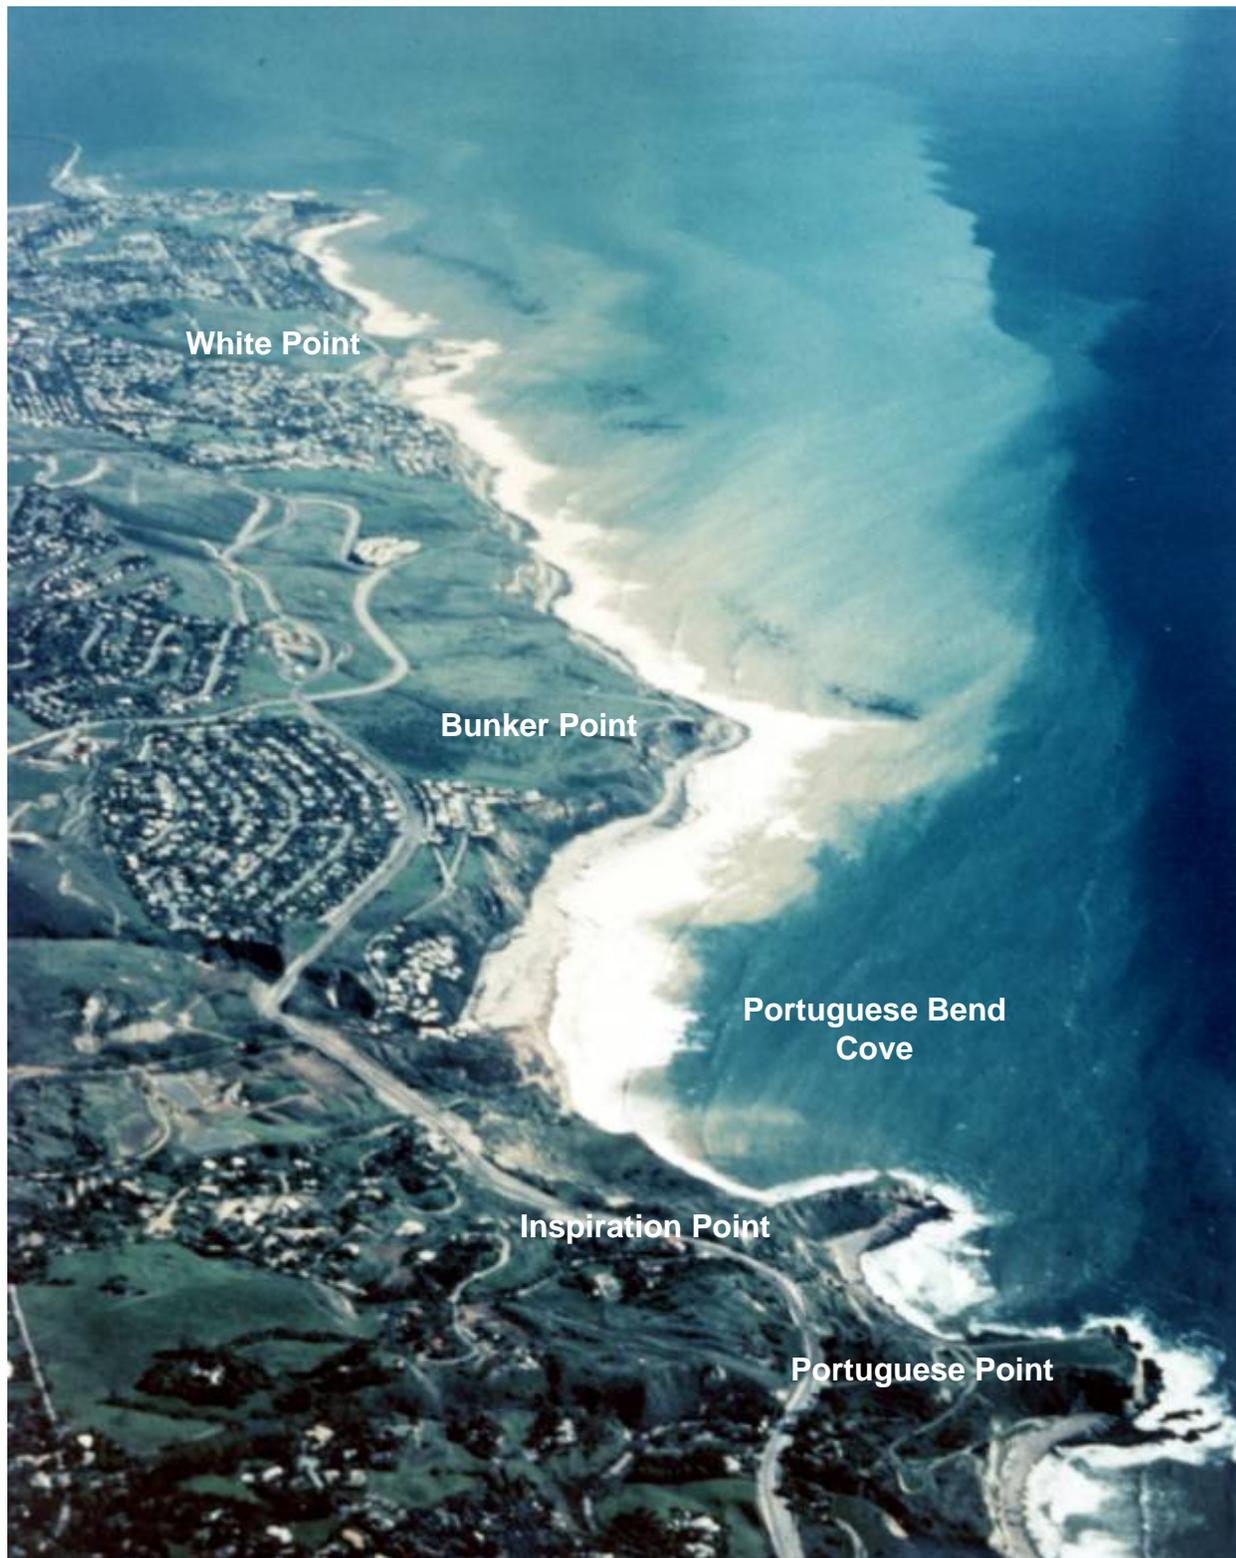
**Figure 4. Example of turbidity plume from the Portuguese Bend Landslide**

Photograph taken sometime in the 1980s, although similar plumes can still be observed today.

The Portuguese Bend Landslide occupies a 1.06 km<sup>2</sup> portion of the PV Peninsula. It is estimated that from 1956 to 1999 the landslide contributed between 5.7 to 9.4 million metric tons of sediment to the inner shelf.<sup>16</sup> A sediment plume has been visible in the waters off Portuguese Bend since the reactivation of the landslide in 1956 (Figure 4). The direction of the sediment plume is usually towards the southeast, and during heavy erosion events may extend out to 1.5 km.<sup>16</sup> The sedimentation from the landslide reaches as far south as White Point, where it is known to mix with the wastewater effluent, thus enlarging the sediment deposit on the highly contaminated solids that were discharged from the outfalls.<sup>16</sup> This sedimentation continues to bury rocky reefs in this region (Figure 5). In addition, the longshore current does shift, causing the sediment plume sometimes to extend upcoast to Long Point. The Portuguese Bend landslide is a major source of sediments to the rocky subtidal and intertidal environment.<sup>19</sup>

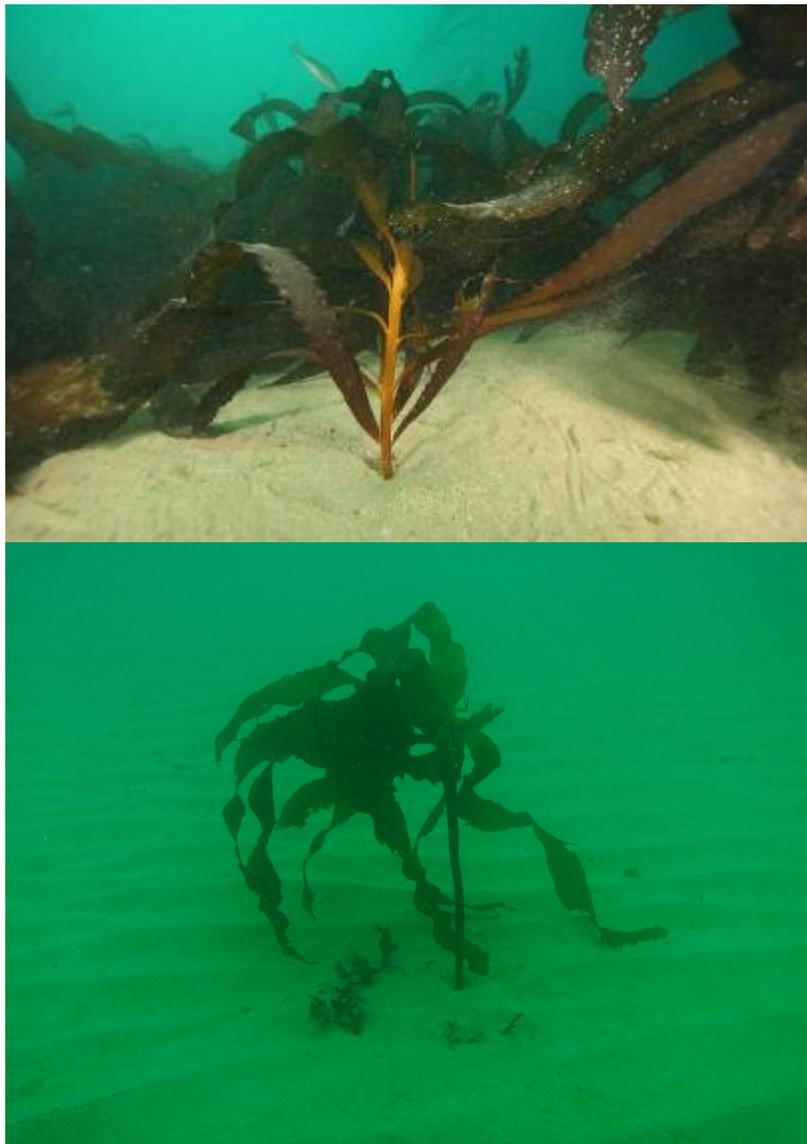
**Figure 5. Examples of buried reef at Bunker Point and White Point**

Bunker Point (above), October 22, 2008 and White Point (below), June 3, 2009.
